# BUILDING INSPECTION REPORT

**INSPECTION ADDRESS: 7586-7596 West Jewell Avenue, Lakewood, CO**

**INSPECTION DATE: July 12, 2007**

**Re. 7586 & 7596 West Jewell Avenue, Lakewood, Colorado - Creekside**

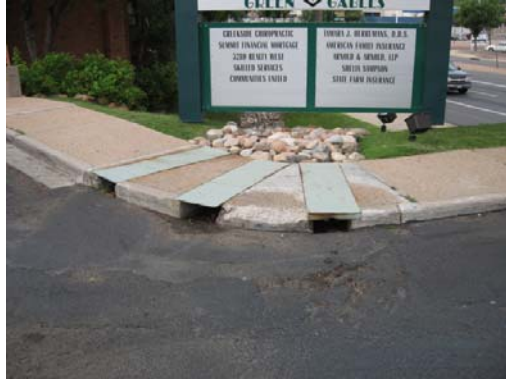
The grade slope around the building, intended to provide positive drainage away from the foundation, is considered adequate with some concerns noted at the north side of the 7596 building where it appears that runoff water may be accumulating adjacent to the garden level wall causing the interior brick masonry of this foundation wall and visible in the common lobby area to have mineral deposit buildup at grout joints and on the face of the exposed brick masonry.

(2) Grade drainage @ parking lot

- *Due to the sloped nature of this property that directs substantial runoff water towards the building structures on the north regularly scheduled monitoring of the grade and drainage conditions is required.*
- *Grading improvements @ the north side of the 7596 building to ensure adequate drainage flow away from the building's foundation is required.*

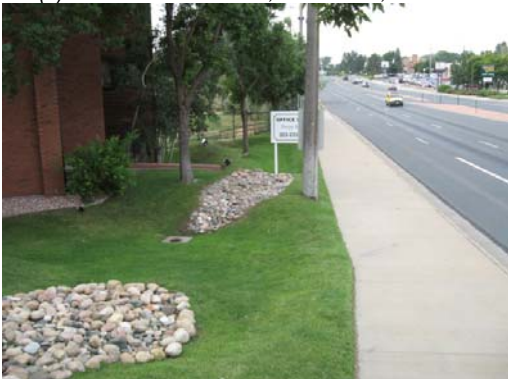
(3) Grade drainage retention/catch basin (west)

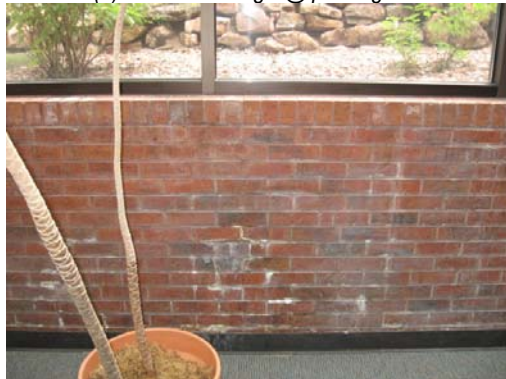
(4) Mineral deposit on brick masonry (7596)

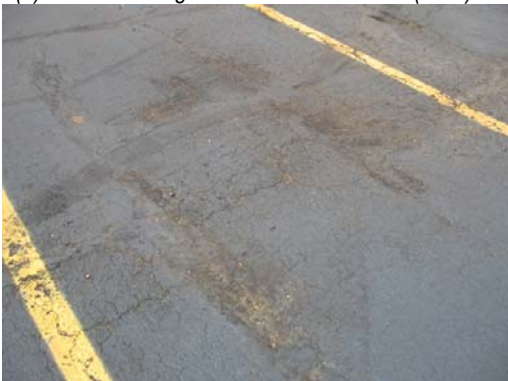
There is ample parking available in the north parking lot with approximately 109 spaces available with one space identified for handicap parking. The asphalt parking area and driving lanes for the two building facility has a recent seal coat and parking space paint marking application, however, there is moderate irregular cracking and surface deterioration in driving lanes and at parking space locations.

(5) Parking lot surface deterioration

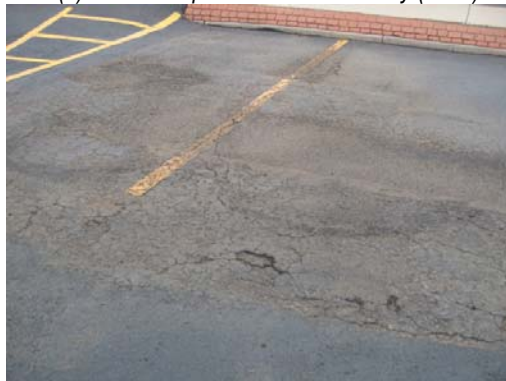
(6) Parking lot irregular cracking/pothole

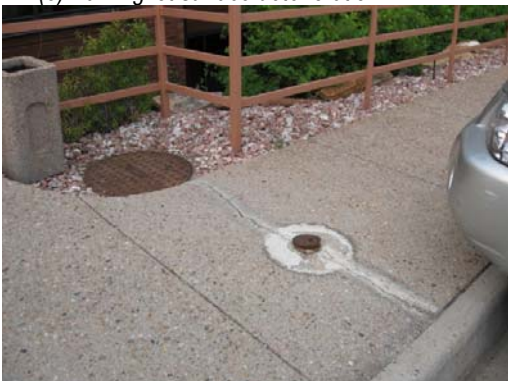
(7) Water main valve @ 7596 trip-hazard

- *Sidewalk repairs for potential trip hazards is required, including a repair for the lifted water main shut-off valve.*

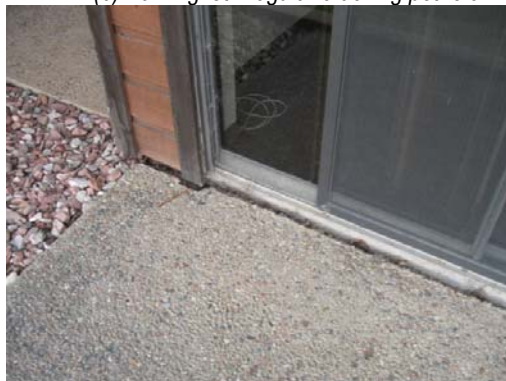
The lower level tenant spaces include concrete patios on the south side of the building. Several of the patio structures have settled (7596 -101, 7586 -104/105). The exterior egress stairways located at the center of the two buildings and leading to the central courtyard area do not have handrail protection as required. The egress stairway door landing at the west side of 7596 has settled and presents a potential trip hazard for pedestrian traffic.

(8) Patio settlement @ rear – typical

- *Concrete curb repairs at the southwest corner of the parking lot are required.*
- *Patio repairs to lift and level settled components.*
- *Add handrail protection for exterior egress stairways and level egress stairway landings to provide for safe passage.*
- *Tar sealant application for irregular cracking in the asphalt parking and driving lanes is required, at minimum. Asphalt patch repairs may prove to be the most beneficial repair for areas with significant deterioration.*

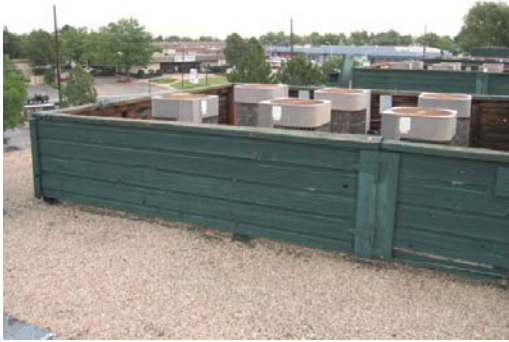
Each building roof also includes a wood fence air conditioning equipment enclosure on the flat roof sections. The wood fencing display substantial paint and wood deterioration.

(9) Flat roof/equipment enclosure – deterioration

- *Monitor the roof covering and structure on a regular basis.*
- *Restoration of the deteriorated flat roof coverings of both buildings is required.*
- *Wood and paint restoration for the roof-top-mounted air conditioning equipment enclosure fences is required.*

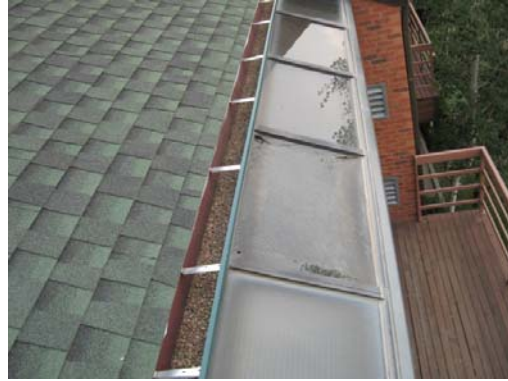
are atrium windows on the south side of these buildings for the upper level tenant spaces and one of the window units in unit 7596-304 is broken. The majority of these sliding doors were in fair to poor condition with damaged door-locks, and worn roller hardware.

(10) Broken atrium glass 7595 304

- *Repair windows with broken seals and broken window glass is required.*
- *Service/repair for all sliding glass doors in all tenant spaces is required.*

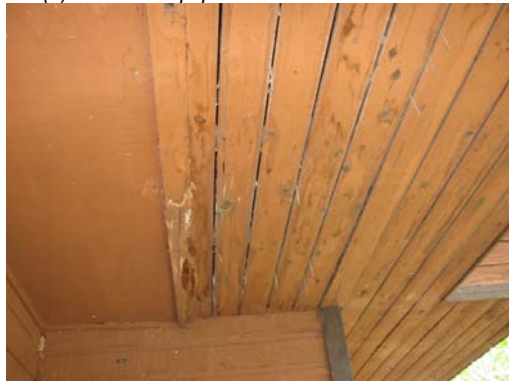
(11) Under deck – 7596 303-304

- *Monitor the exterior walls on a regular basis.*
- *Repair sagging deck components @ the second level center units of each building.*
- *Cedar siding restoration repairs for damaged and deteriorated wood components and sealant application.*

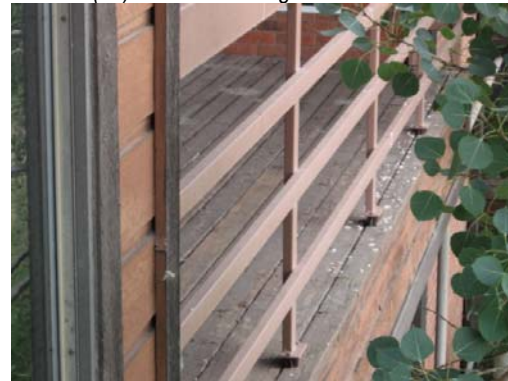
(12) Shims under railing @ center decks – typical

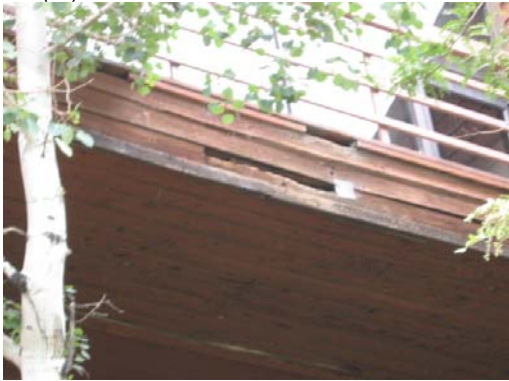
All exterior brick masonry walls appear to be reasonably straight and without major defect, with some concerns noted for the cedar siding components on the rear and sides of the buildings, and sagging deck features on the south side of each building. The two center decks at the second level of each building are sagging at the center. These same deck components have wood spacers added at the mounting bases of the metal railings to accommodate the settlement of the deck structures. The cedar wood siding on the south side of each building at the decks and soffits display sealant and wood deterioration. There are also

(13) Deteriorated cedar siding @ 3<sup>rd</sup> level deck

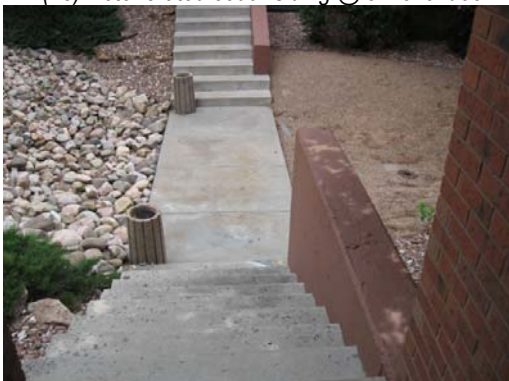
(15) Center egress stairways – no hand rail

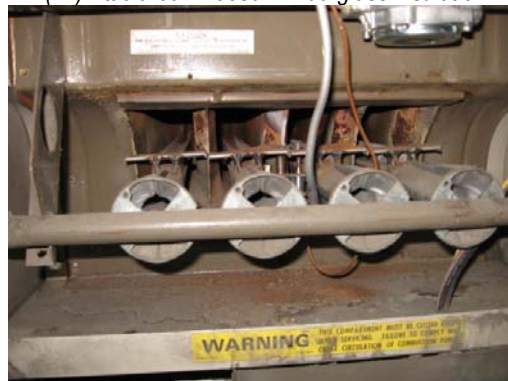
Heating and cooling for the two tenant spaces in the building structure is provided by thermostatically controlled natural gas furnaces with central air conditioning installed. These HVAC systems are installed in the equipment closets of each tenant space on each floor level, with the air conditioning condenser units installed on the roof of each building. The mechanical closets were found to be filthy with dirt, debris, and full of spider webs. The HVAC equipment models are consistent for each tenant space. These units are LENNOX brand model number G12Q4-110-4, rated at 110,000 Btu, and are original to construction at 23 – 24 years old. The majority of the furnace units display moderate to substantial rust/scale deterioration visible at the bottom of the heat exchanger where the natural gas burner tubes insert into the heat exchanger, and it does not appear that filters are being serviced on a regular basis. The air conditioning coils installed for each system are LENNOX brand model number C16-46-1FF, and the condensing units installed on the roofs are also original equipment, and each of the original condensers exhibits moderate hail impact damages to the fin coils. Two of the thirty-six (36) condenser units have been replaced with new equipment in the last 3 – 4 years. Due to the age and our initial visual evaluation of the HVAC equipment installed at this property, it is likely that this equipment has reached or exceeded its design life expectancy.

(16) Furnace unit with rust deterioration – typical

- *Regularly scheduled service and inspection for the HVAC equipment is required to be completed by a licensed heating, cooling and ventilation contractor.*
- *Evaluation of this equipment should be completed to determine the physical and operational condition prior completing the real estate transaction. Replacement of the HVAC equipment is likely to be required in each tenant space.*
- *Clean furnace equipment rooms.*

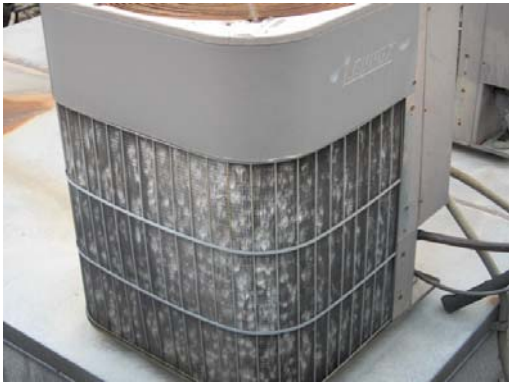
Additional cooling capacity for unit 7596-304 is provided by a rooftop-mounted electric air conditioning unit that is a BDP Company brand model number 559EJ30, serial number 0284C49445, estimated to be 23-years old, and the fin coil exhibits moderate hail impact damages.

(17) A/C condensing coil – hail damage – typical

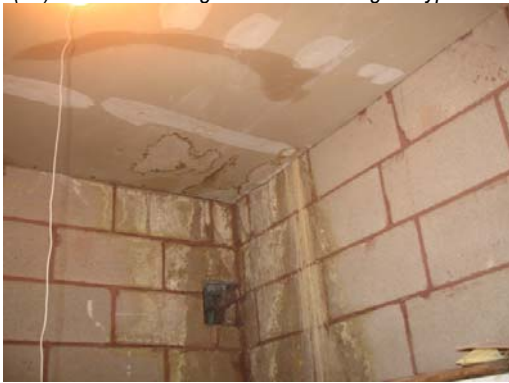
The elevator equipment rooms are poorly maintained with additional equipment and supplies. There are holes cut in the ceiling and the upper far right-hand corner of each equipment roof has substantial water damage from floor sinks installed in the equipment room/janitors closet located directly above the elevator equipment rooms of each building. An unidentified fluid was viewed in the base of the elevator shaft of unit 7596. It was also noted that hydraulic oil staining was viewed on the floor of the elevator equipment room for the 7586 building.

(19) Elevator equipment room – water damage- 7596

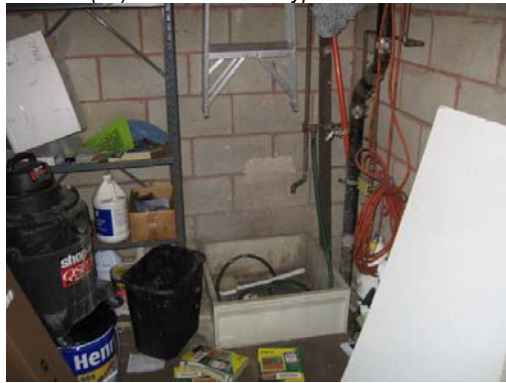
(20) 2<sup>nd</sup> level mechanical/janitor closet -7596

- *Interior finishes will be dependant upon the needs of future tenant occupants.*
- *Repairs for the common area equipment rooms for gypsum board finishes.*
- *Egress door closer repair.*

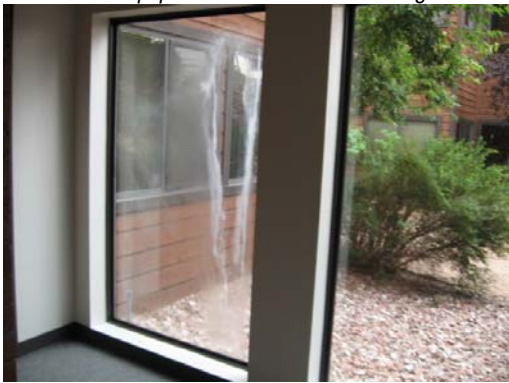
(21) Main level west – 7596 broken seal

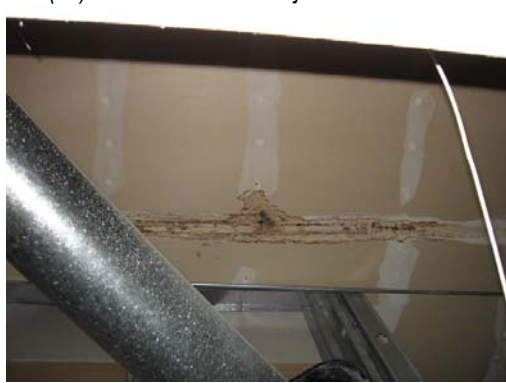
Each building has a combination hip/flat roof configuration. The roof profile material on the hip sections of roof is comprised of dimensional composition asphalt shingles that are estimated to be 6 – 7 years old and in good condition. The flat roof sections of both buildings are covered with a built-tar & gravel system that was viewed to be in fair condition and estimated to be original to construction (24-years old). Sections of the bitumen asphalt material (tar) are “boiling” through the gravel covering, an aging process that allows the tar material to become brittle and to deteriorate. Flashing components for mechanical, plumbing, and electrical penetrations, through the flat roofs of both buildings, exhibit crack deterioration of the sealant materials. One tenant space (7586 – 305) in the east building on the third floor has current roof leaks in the women’s restroom & the employee lounge, per the business owner.

(22) Roof leak @ 7586 - 305
